HARMONY ACURA

2010 HONDA CR-V

STOCK #: AU2573A

Acura Multi-Point Vehicle Inspection Checklist

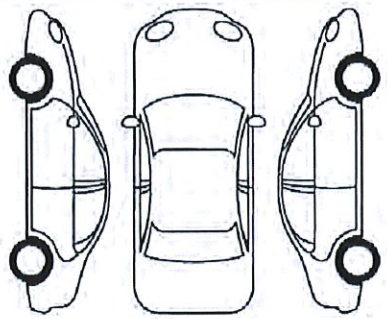
Please Indicate Areas of External Damage or Wear
